# **OPERATING EXPERIENCE WEEKLY SUMMARY**

**Office of Nuclear and Facility Safety**

**April 30 - May 6, 1999**

**Summary 99-18**

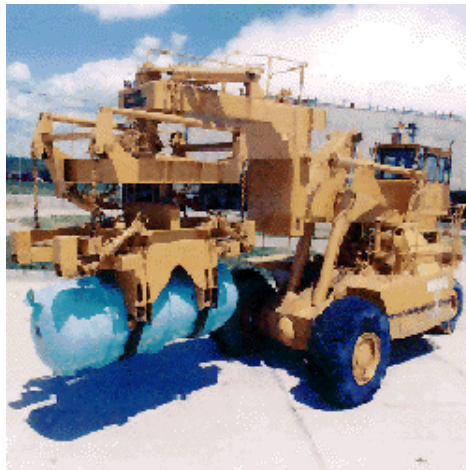
Figure 2-1. DOE-NCH-35 Cylinder Hauler

The cylinder hauler, which is used to transport 14-ton depleted uranium hexafluoride casks, is manufactured by Allied Wagner (figure 2-1). It is one of three at Paducah and had been in use for between 5 and 7 years. The guide blocks, which are mounted on top of the boom of the cylinder hauler, guide hydraulic lines when the cylinder hauler operator is extending or retracting the boom. Although the guide blocks, their mounting brackets, and the bracket welds do not serve a safety function, the boom is classified as a safety-significant component. By performing dye penetrant checks after the guide block welds were removed, investigators determined that the cracks in the guide block welds had propagated into the base metal of the cylinder hauler boom, which could have caused a structural failure. They believe that fatigue from the sliding motion of the guide blocks caused the cracks and their propagation into the boom. Engineers also found cracks in the guide block welds of the other two cylinder haulers at Paducah and are investigating to see if those cracks have also spread into the booms. No weld cracks have been identified in the cylinder haulers at the Portsmouth or ETTP facilities.
